1949 - CID510160_TazewellCounty_CFPF-1

Funding Opportunity: 1447-Virginia Community Flood Preparedness Fund - Project Grants - CY23 Round 4
Funding Opportunity Due Date: Nov 12, 2023 11:59 PM
Program Area: Virginia Community Flood Preparedness Fund
Status: Under Review
Stage: Final Application

The Richlands School Area is comprised of three schools: Richlands Elementary School, Richlands Middle School, and Richlands High School. In addition to the vital role schools play for the community, in Richlands they also act as emergency shelters during disasters. The main challenge is the inadequate stormwater infrastructure along Cedar Valley Road, leading to frequent blockages and overflow. This results in the main entrance to the schools being blocked, posing significant access and safety issues during critical times, including emergencies. Enhancing the stormwater management system is imperative for the safety, accessibility, and resilience of the community. Similarly, the neighboring middle schools auditorium experiences frequent inundation, potentially originating from groundwater and runoff from the elevated terrain behind the school. The proposed project would conduct a study of

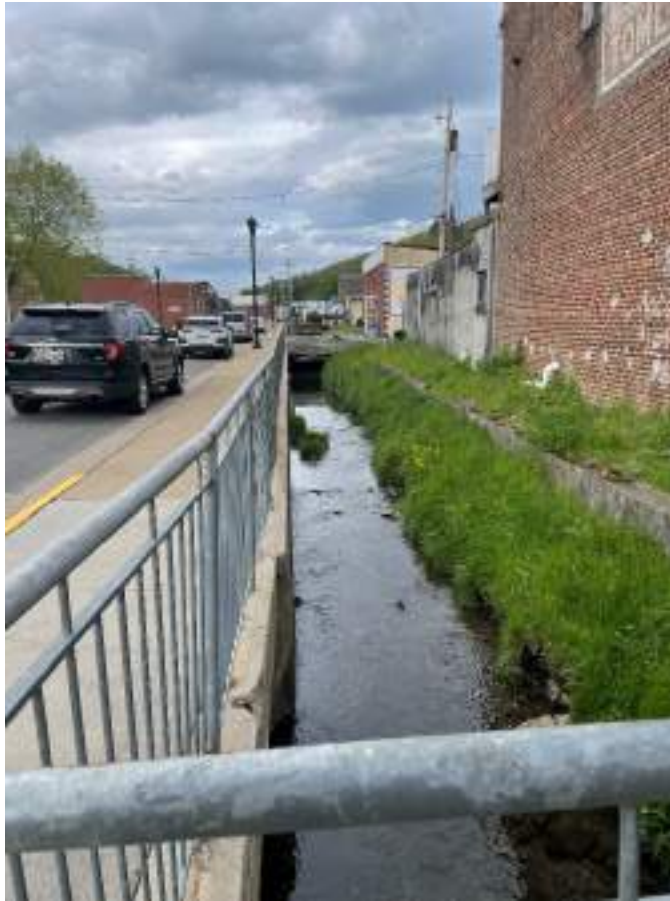
Figure 34: Creek running alongside Spring Street and Premier Realty

- The Reynolds Avenue and Dudley Street areas frequently flood during heavy rains blocking access and impacting homes. Many residents move their cars, appliances, and electronics to higher elevations during rain events to help mitigate flooding damage. Residents report stream bank erosion and debris issues throughout the area. They also believe flooding has gotten worse from nearby development.

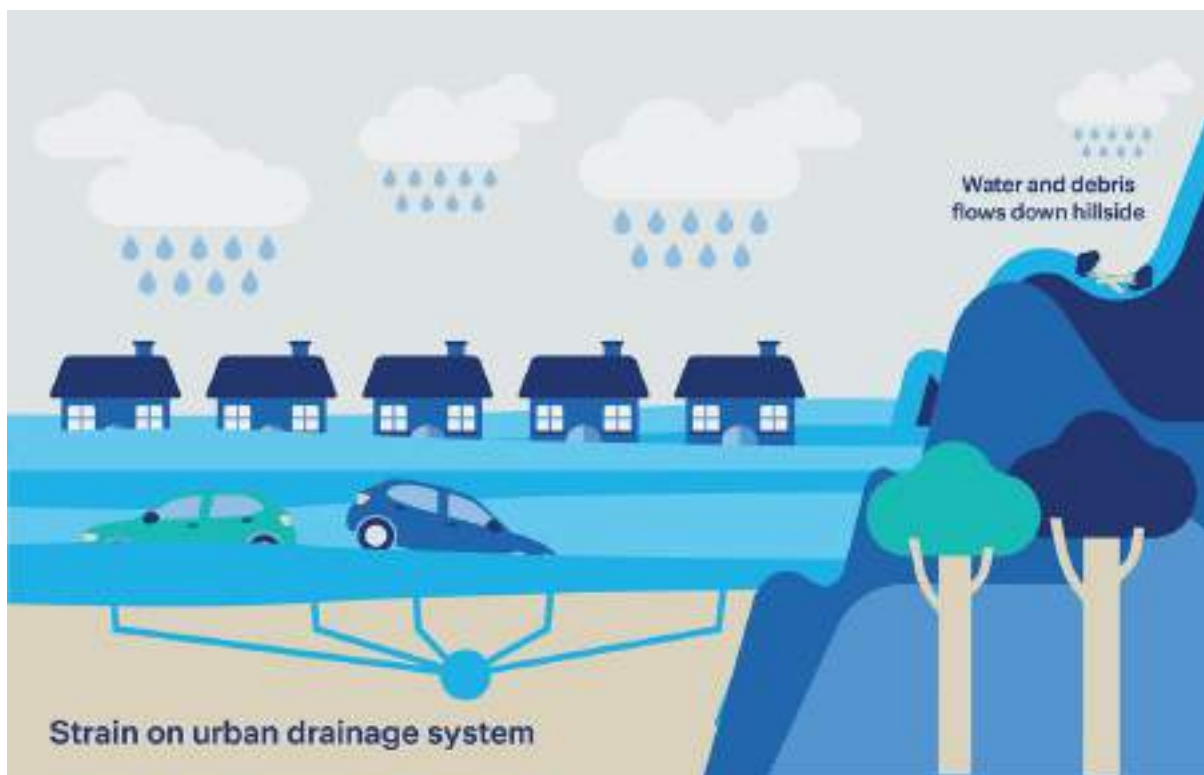
Figure 61: Rainfall-induced (Pluvial) Flooding²

In addition to development, shifts in the global climate are resulting in more frequent and more intense extreme precipitation events in certain locations, including Tazewell County, which contributes to increased flooding. Extreme precipitation events may overwhelm the design capacity of existing drainage systems and result in rainfall-induced flooding or flash flooding. Flash floods occur within a few minutes or hours of heavy amounts of rainfall and can destroy buildings, uproot trees, and scour out new drainage channels. Most flash flooding is caused by slow-moving thunderstorms, repeated thunderstorms in a local area, or by heavy rains from hurricanes, tropical storms, and their remnants. Flash flooding often occurs in mountainous areas and is also common in urban areas where much of the ground is covered by impervious surfaces. In addition to flash flooding, steep slopes that are oversaturated during extreme rainfall events may prompt slope failure, resulting in landslides, mudslides, and debris-flows.

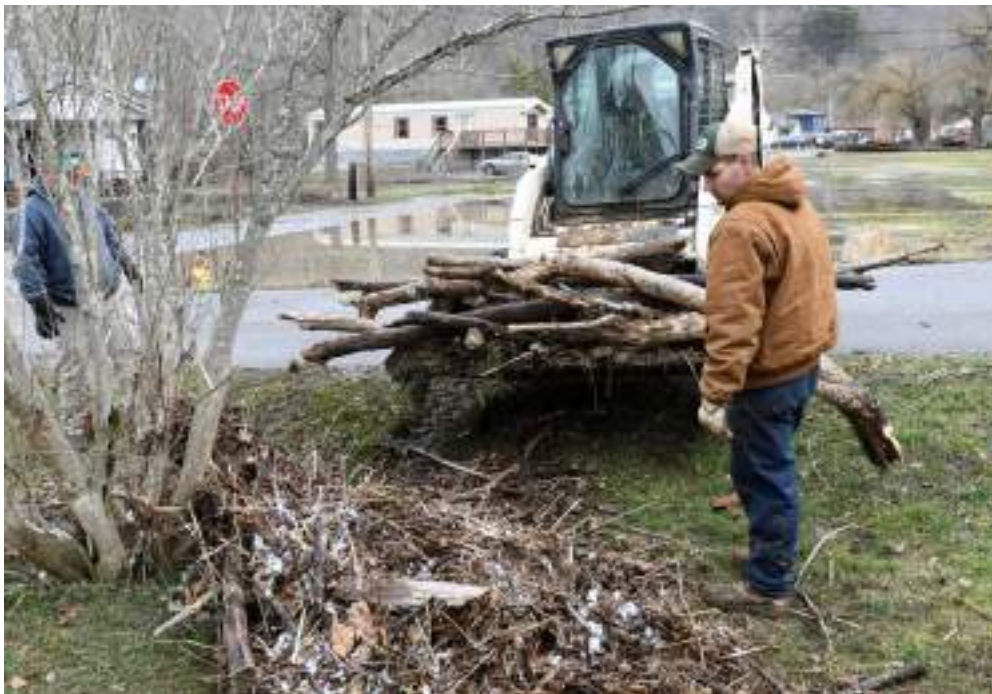
Figure 614: Flood Debris from February 2020 flooding in Richlands, VA²³

Natural debris, such as woody vegetation and sediment from erosion, can also restrict the natural capacity of the stream (e.g., sediment building up on the streambed) and contribute to flooding. Natural debris left by a flooding in Richlands flowing a 2020 event is shown in Figure 614. When not cleared, especially after a flood event where areas pile up with debris, a hazard is created as the stream is essentially dammed and increases the likelihood that a rainfall event will become a major flood event.

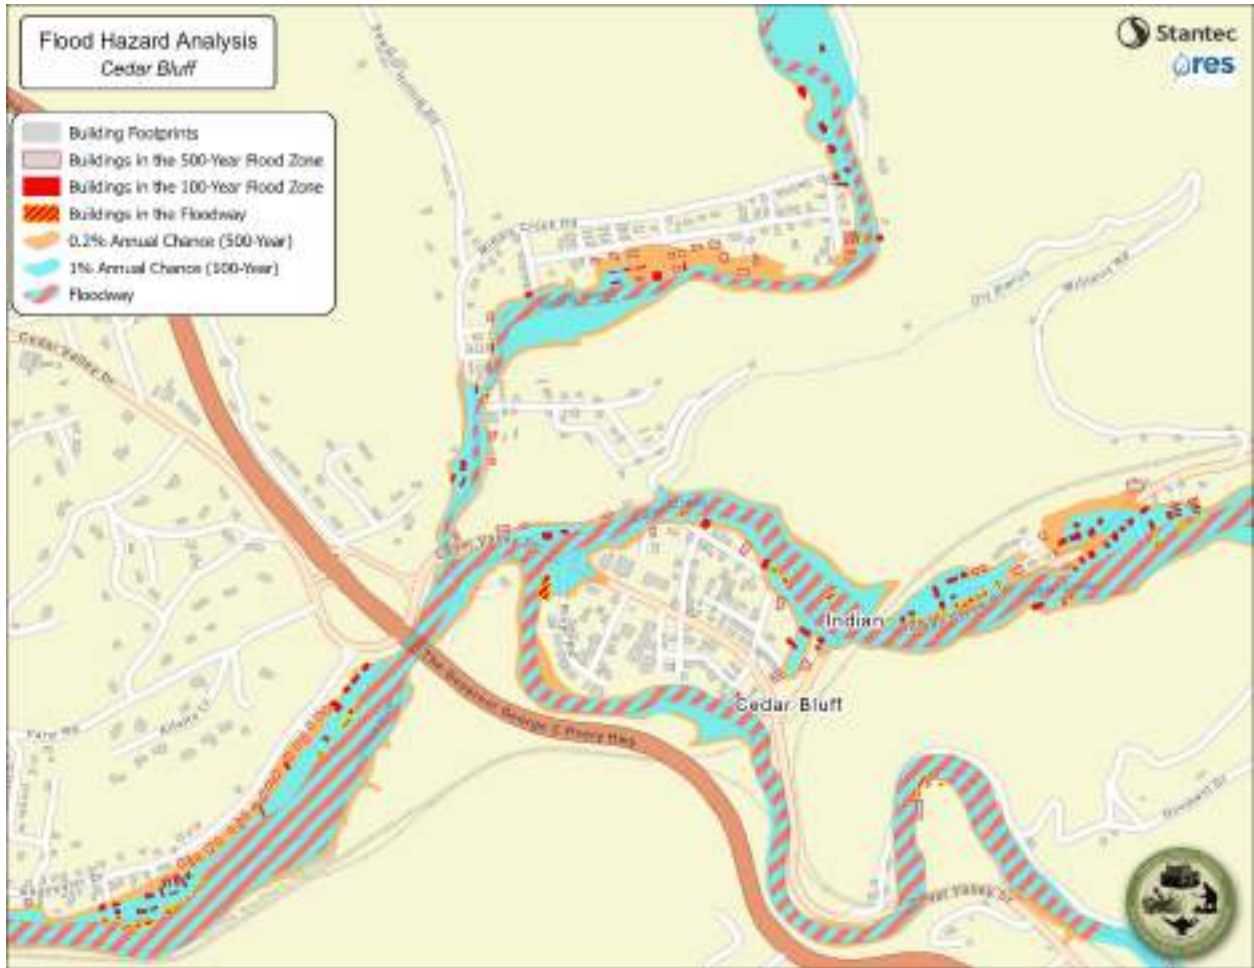
Figure 630 – Figure 639 show areas throughout the Tazewell County where there are clusters of buildings located in the FEMA flood zones.

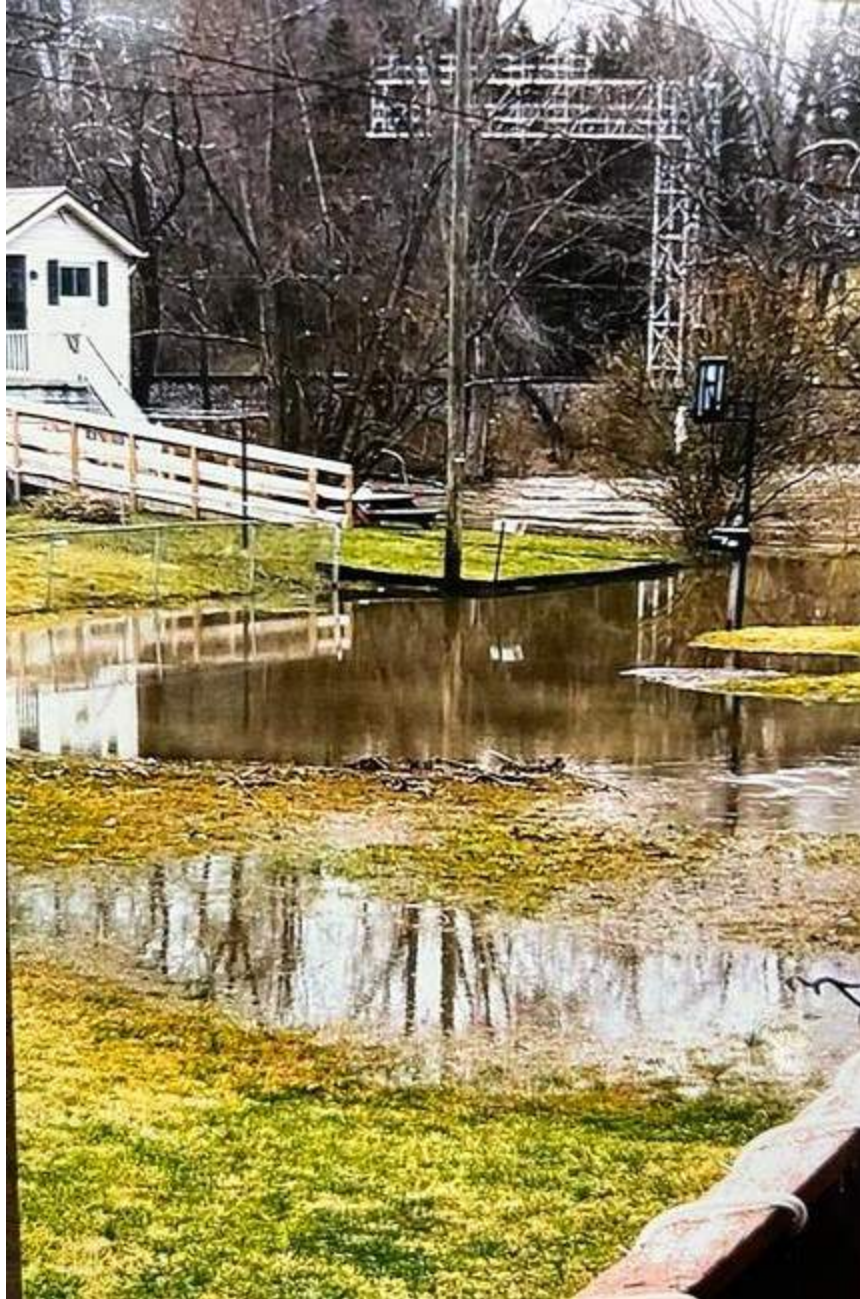
Figure 643: Floodwaters on the East End of Blacksburg Street

During past flood events, floodwaters have overtopped the bank of the Clinch River at the east end of Blacksburg Street and travelled up the road to the west. This is a regular occurrence and is shown in Figure 643 in a photograph provided by a resident of the community. Flooding impacts all the homes located along the south side of the street. In a public meeting with Blacksburg Street residents, many community members voiced that they have to move their vehicles out of the area when heavy rainfall is predicted and most are concerned that their homes will eventually be severely damaged during a severe flooding event.

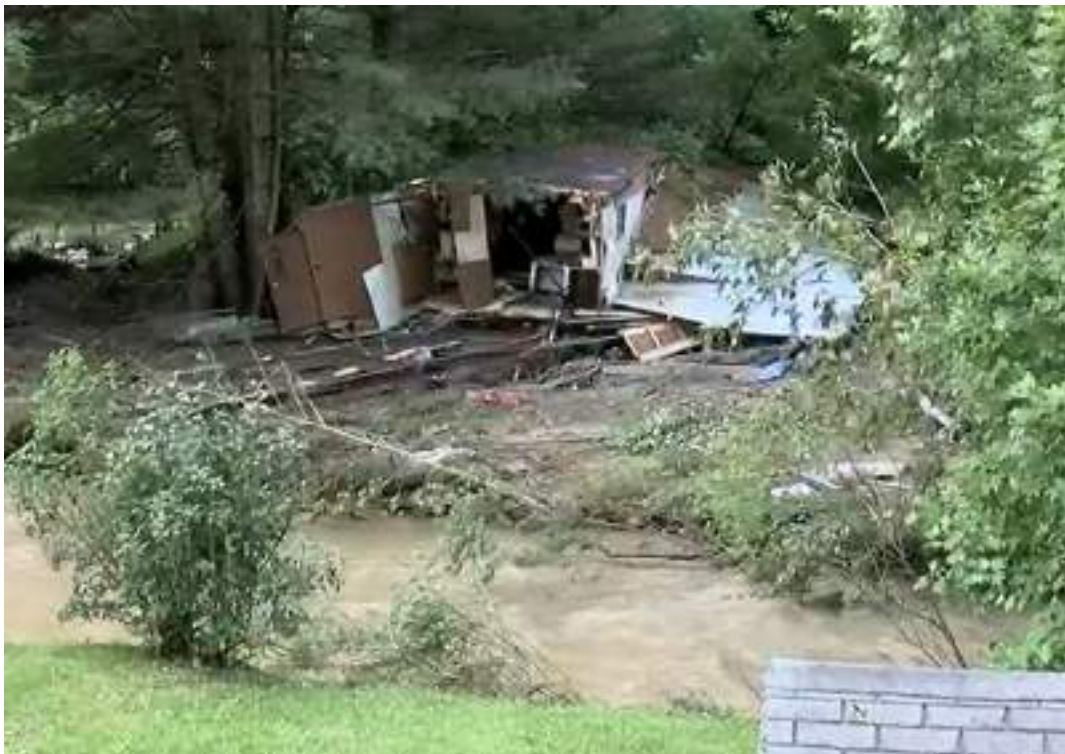
Figure 644: Mobile Home that was Destroyed during the July 2022 Flood Event in Bandy, VA⁵¹

Structures exposed to flooding, including critical facilities, can be severely damaged by floodwaters. Building contents can be lost, damaged, or destroyed, and structures themselves can be compromised by floodwaters. After a flood, wooden structures may rot. Pressure from floodwater, especially as seepage through soil, can damage building foundations. Furthermore, the force of rushing floodwaters can push whole structures off their foundations. Mobile homes and manufactured homes that are not elevated or properly anchored to a permanent foundation are more susceptible to being lifted up and carried hundreds of feet during a flood event, as illustrated in Figure 644. When this occurs, not only is the structure itself damaged or destroyed, but the structure then becomes a threat to other structures, property, and residents as it travels downstream.

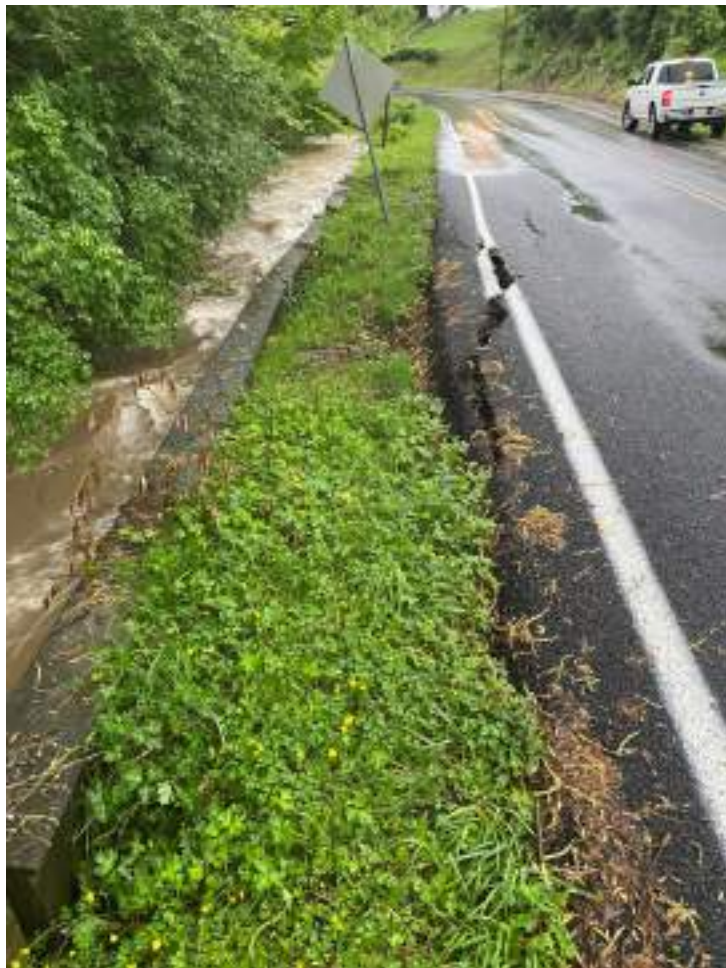
Figure 645: Road Damage in Bluefield, VA from Flooding in March 2023

Infrastructure Type	Vulnerability to Flooding
Water / Wastewater	<p>Water and wastewater systems and facilities have the potential to be impacted by flooding, resulting in costly damages and prolonged service outages. Treatment facilities may become inundated or inaccessible due to floodwaters. Pump stations may become damaged. When roads are washed out, or during landslides, underground water mains and sewage conveyance systems may break. During main breaks, bacteria may be introduced to drinking water systems or low pressure may cause service disruptions. Further, the Town of Richlands Wastewater Treatment Plant (WWTP) has experienced issues with stormwater infiltration and overflows. During heavy precipitation events, stormwater infiltrates the sewer lines, increasing the flow into the Richlands WWTP and leading to untreated wastewater entering the Clinch River.</p>

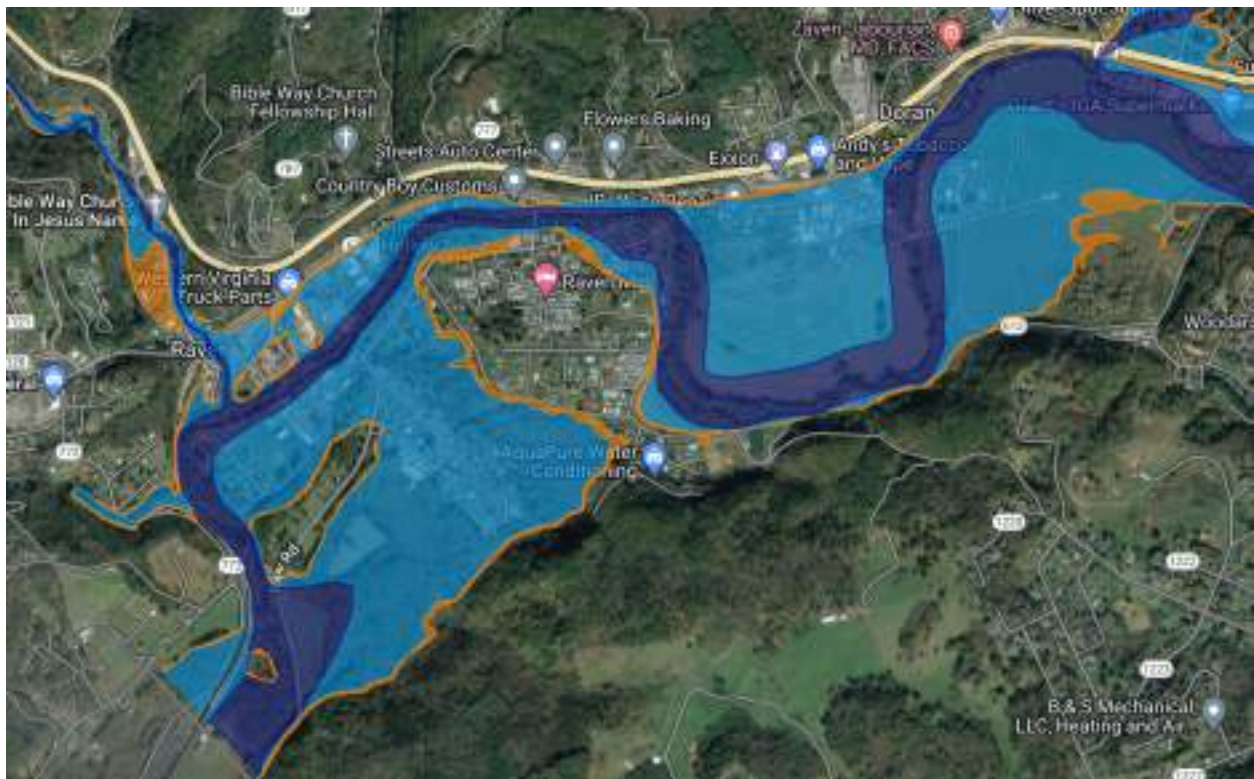
Figure 729: Traditional 1D Modeling

2D Base Level Engineering (BLE) hydraulic modeling is an emerging type of modeling that has many benefits. Traditional floodplain mapping (1D) is tied to streams and is developed for flood insurance requirements. It also has limitations to tie to underground stormwater sewers. Traditional models stop at a set boundary surrounding a stream and are developed as cross sections. The areas between cross sections are interpolated which can limit accuracy. Traditional modeling is also limited to showing one direction of water flow, has limited integration of structures, and has limited velocity visualization. An example of 1D modeling is shown in **Figure 729**.
