1985 - CID510160_TazewellCounty_CFPF-3

Funding Opportunity: 1448-Virginia Community Flood Preparedness Fund - Study Grants - CY23 Round 4

Tazewell County is requesting assistance to complete a comprehensive study of the persistent flooding in the Bottom Road Area in the Raven and Doran communities. Using data-driven approaches, the study seeks to better understand the root causes of flooding in the area and provide a list of potential mitigation strategies with a focus on nature-based solutions.

Hazard Mitigation Plan Update

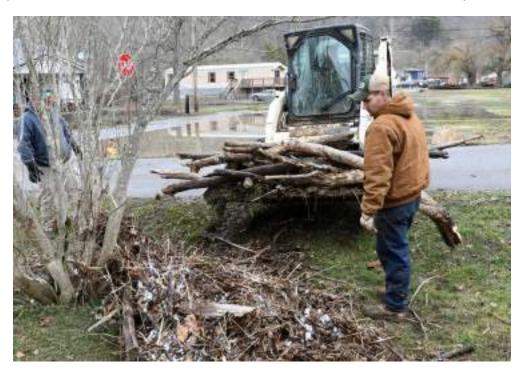
Figure 614: Flood Debris from February 2020 flooding in Richlands, VA²³

Natural debris, such as woody vegetation and sediment from erosion, can also restrict the natural capacity of the stream (e.g., sediment building up on the streambed) and contribute to flooding. Natural debris left by a flooding in Richlands flowing a 2020 event is shown in Figure 614. When not cleared, especially after a flood event where areas pile up with debris, a hazard is created as the stream is essentially dammed and increases the likelihood that a rainfall event will become a major flood event.

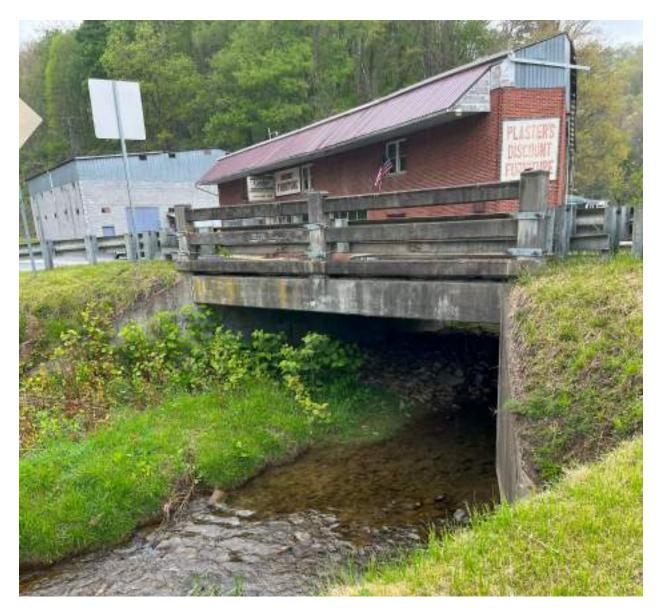
Figure 727: Culvert crossing Mill Creek

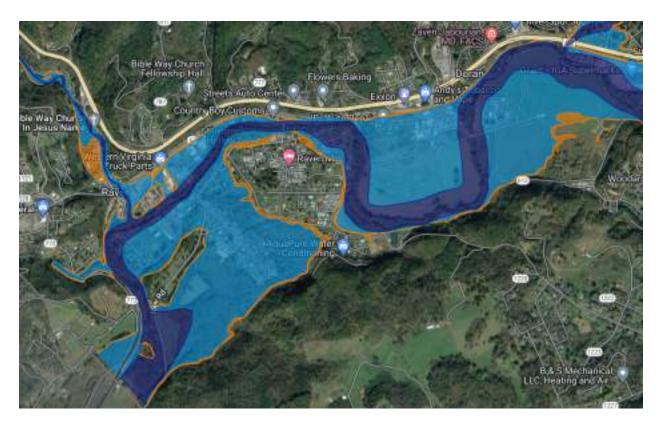
Figure 729: Traditional 1D Modeling
