# 1950 - CID510160\_TazewellCounty\_CFPF-2

**Funding Opportunity:** 1448-Virginia Community Flood Preparedness Fund - Study Grants - CY23 Round 4  
**Funding Opportunity Due Date:** Nov 12, 2023 11:59 PM  
**Program Area:** Virginia Community Flood Preparedness Fund  
**Status:** Under Review  
**Stage:** Final Application

The study aims to evaluate the removal of the mill building and dam and address the Blacksburg Street Community's urgent need for mitigating frequent flooding and restoring the natural flow of the creek. This approach aligns with the local government's priority of protecting the community from flood-related risks, which includes loss of life, property damage, environmental degradation, and disruption to daily life. It demonstrates a commitment to equity and community improvement by regularly and purposefully engaging residents throughout the process. The consideration of nature-based solutions in the study emphasizes the local government's dedication to sustainable and environmentally friendly approaches to flood mitigation.

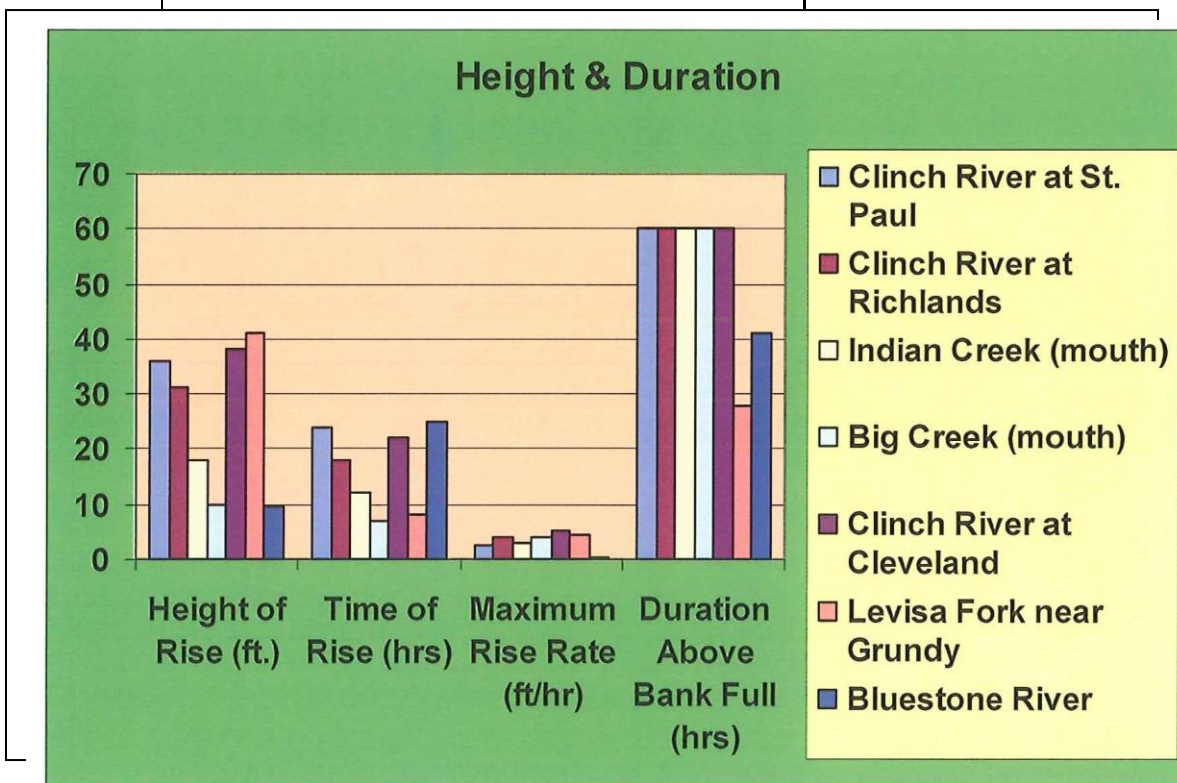
**Figure V-4 — River Basin Flood Heights and Duration**

- Flood depth:** The greater the depth of flooding, the higher the potential for significant damages. Flood depths have been estimated for the maximum probable event for this area by various TVA and Corps of Engineers studies. Flood heights and rise rates in Figure V-4 are based on the Maximum Probable Flood.
- Flood duration:** The longer duration of time that floodwaters are in contact with building components such as structural members, interior finishes, and mechanical equipment, the greater the potential for damage. As stated previously, because of the steep topography of the area, floodwaters tend to recede quickly following an event, but may remain longer in localized areas. Flood durations in Figure V-4 are based on the Maximum Probable Flood.

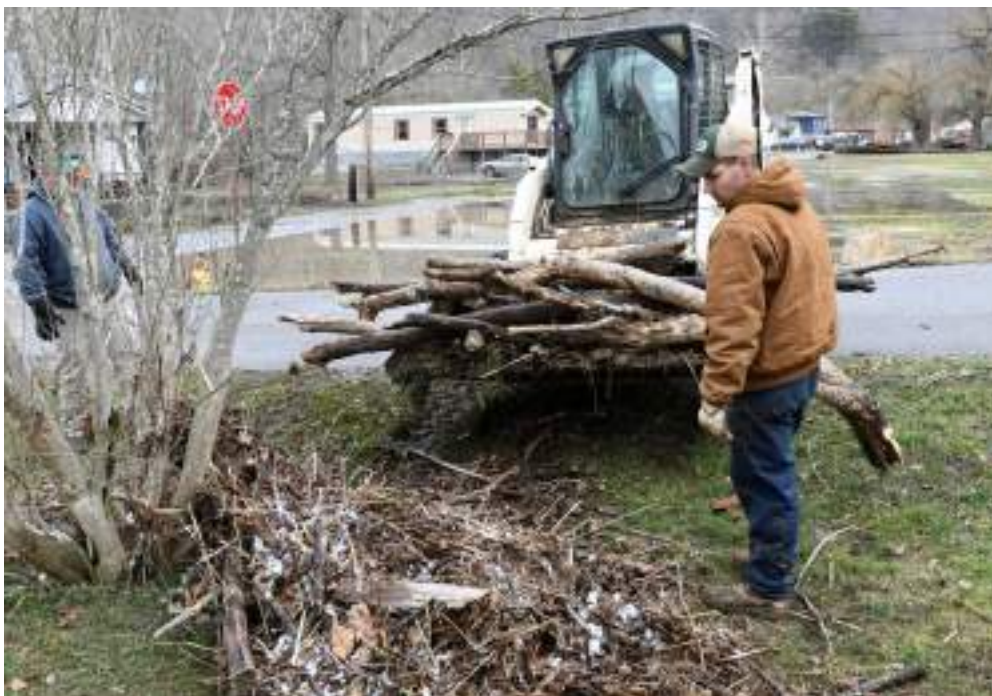
Natural debris, such as woody vegetation and sediment from erosion, can also restrict the natural capacity of the stream (e.g., sediment building up on the streambed) and contribute to flooding. Natural debris left by a flooding in Richlands flowing a 2020 event is shown in Figure 614. When not cleared, especially after a flood event where areas pile up with debris, a hazard is created as the stream is essentially dammed and increases the likelihood that a rainfall event will become a major flood event.

*Figure 614: Flood Debris from February 2020 flooding in Richlands, VA<sup>23</sup>*

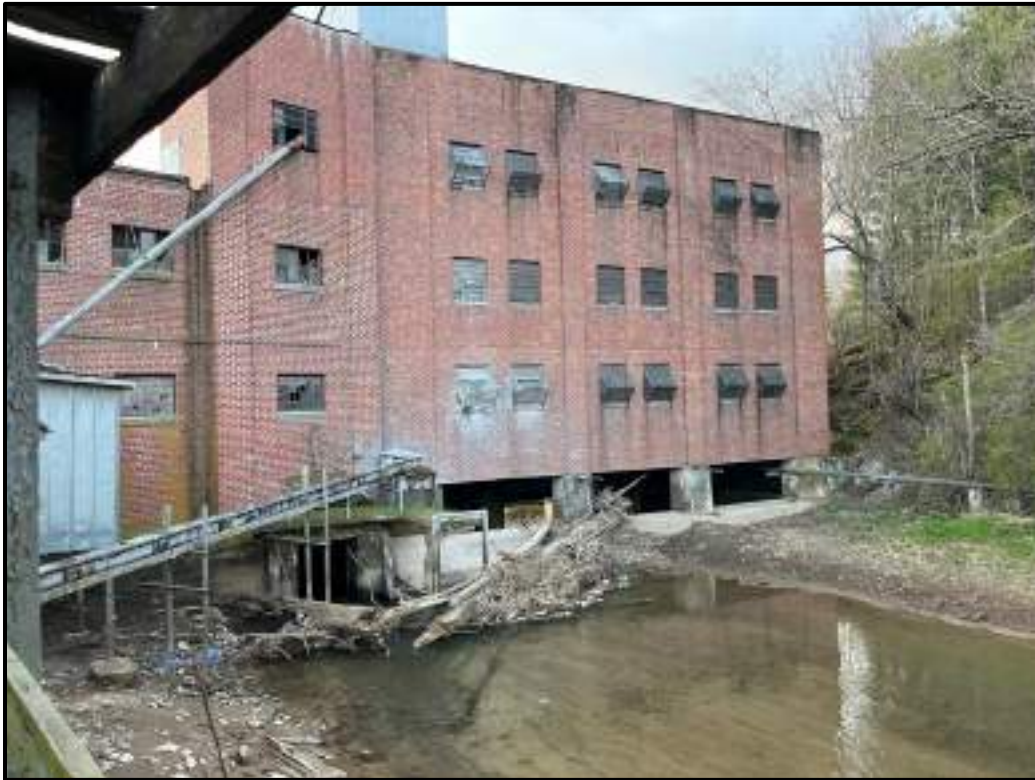
*Figure 71: Mill Building March 2023 capturing debris*
