# 1990 - CID510160\_TazewellCounty\_CFPF-6

<b>Funding Opportunity:</b>	1446-Virginia Community Flood Preparedness Fund - Capacity Building/Planning Grants - CY23 Round 4
<b>Program Area:</b>	Virginia Community Flood Preparedness Fund
<b>Application Status:</b>	Under Review
<b>Stage:</b>	Final Application
<b>Organization:</b>	Tazewell County
<b>Applicant:</b>	Rebekah Cazares
<b>Internal Status:</b>	
<b>Initial Submit Date:</b>	Nov 11, 2023 8:22 PM
<b>Initially Submitted By:</b>	Rebekah Cazares
<b>Last Submit Date:</b>	
<b>Last Submitted By:</b>

## Hazard Mitigation Plan Update

Cumberland Plateau Planning District Commission  
Hazard Mitigation Plan

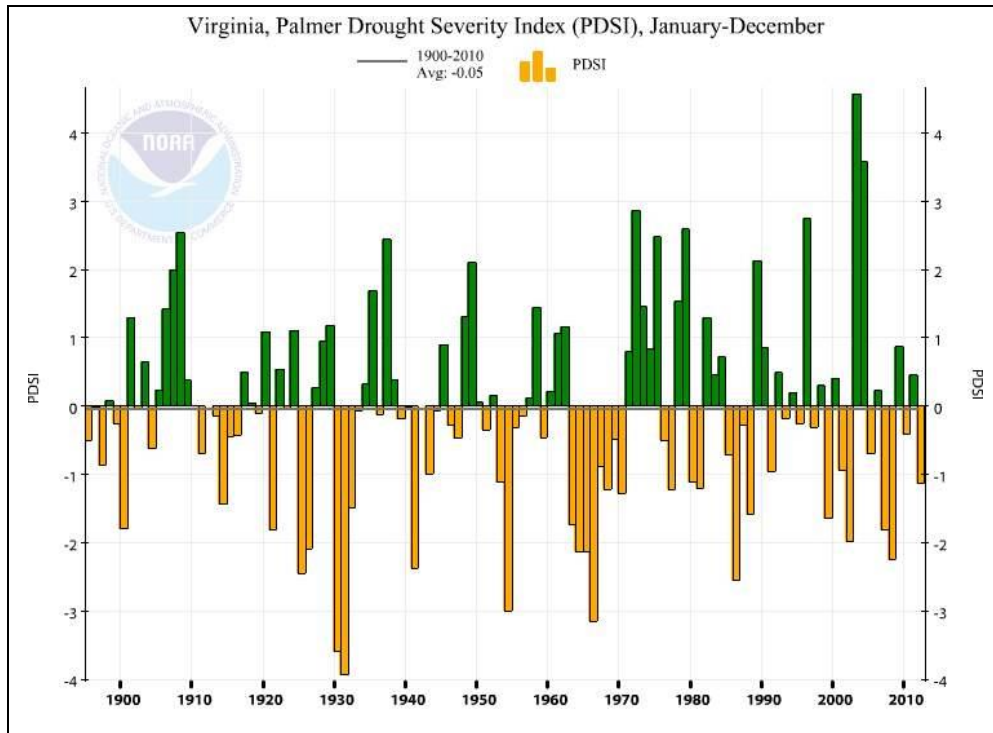
Virginia State Climatology Office  
Figure V-13 —Virginia Palmer Drought Severity Index

The Virginia State Climatology Office uses the Palmer Drought Severity Index (PDSI) to measure long-term moisture status. A reading of -3.0 is considered to be a "severe drought.".Shown below is the PDSI history for Virginia from 1900 through December 1, 2010. .

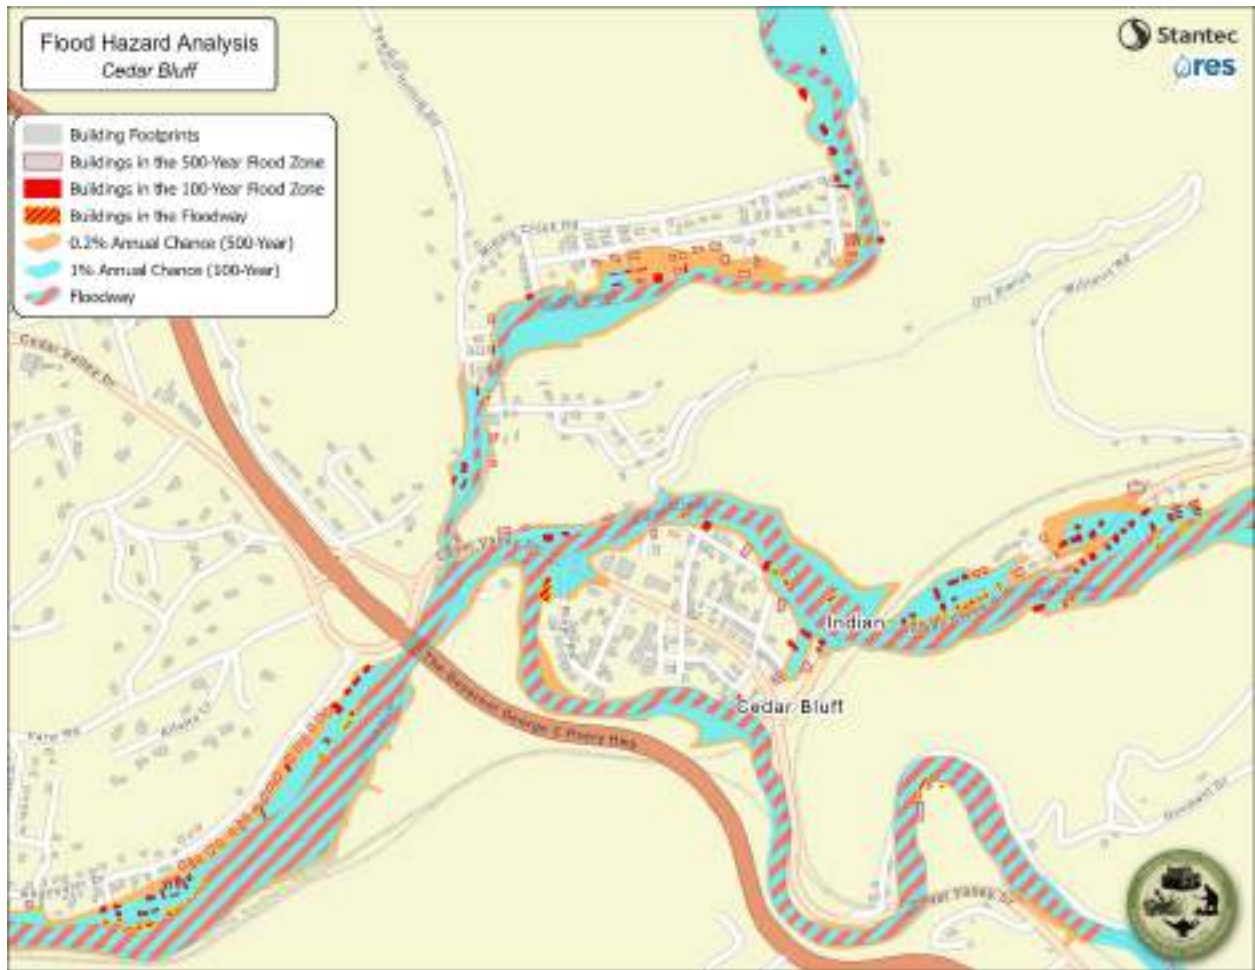
Figure 630 – Figure 639 show areas throughout the Tazewell County where there are clusters of buildings located in the FEMA flood zones.

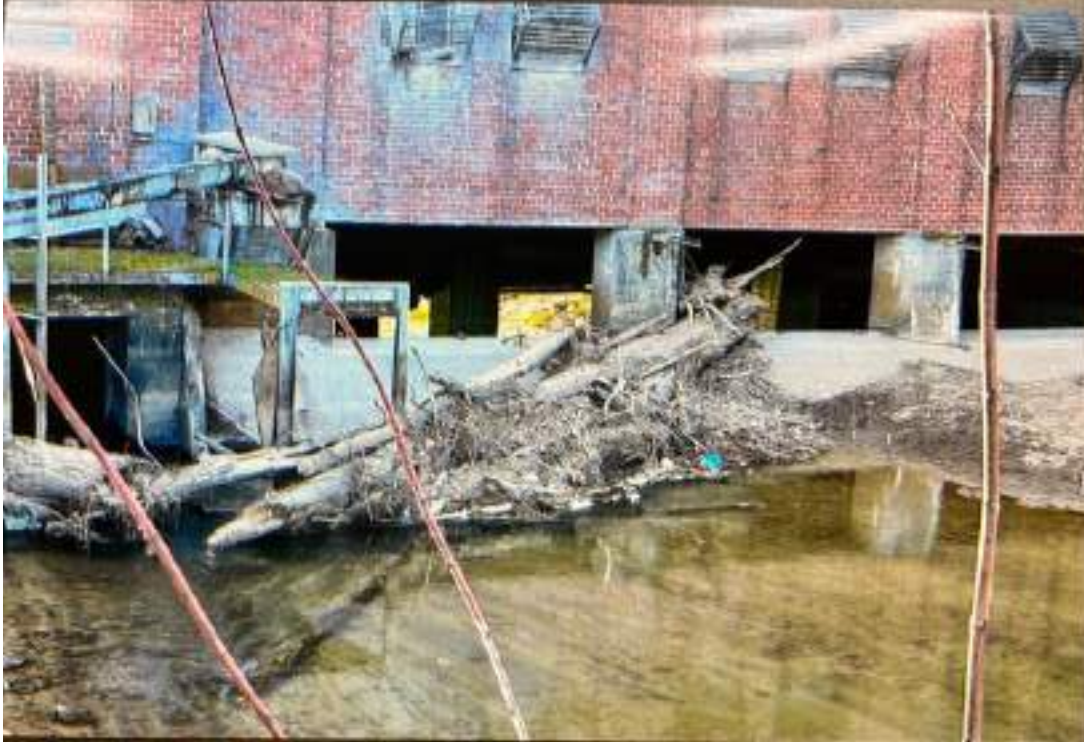
*Figure 642: Debris Gathered on Upstream Side of Abandoned Mill Building in North Tazewell*
