Shoreline Management In Chesapeake Bay

Special Report in Applied Marine Science and Ocean Engineering Number 356

October 1999

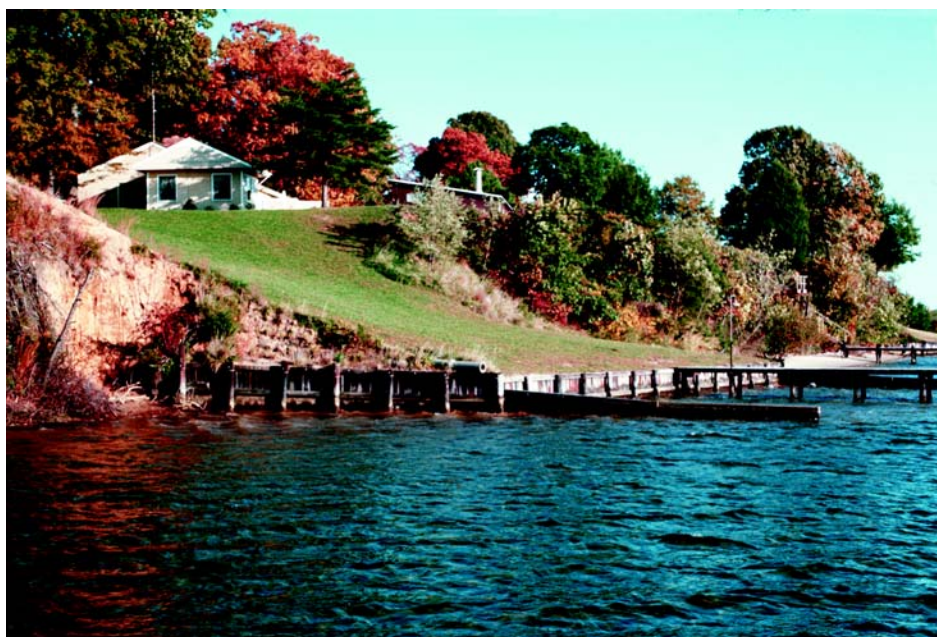
Figure 14A Bulkhead and graded bank.

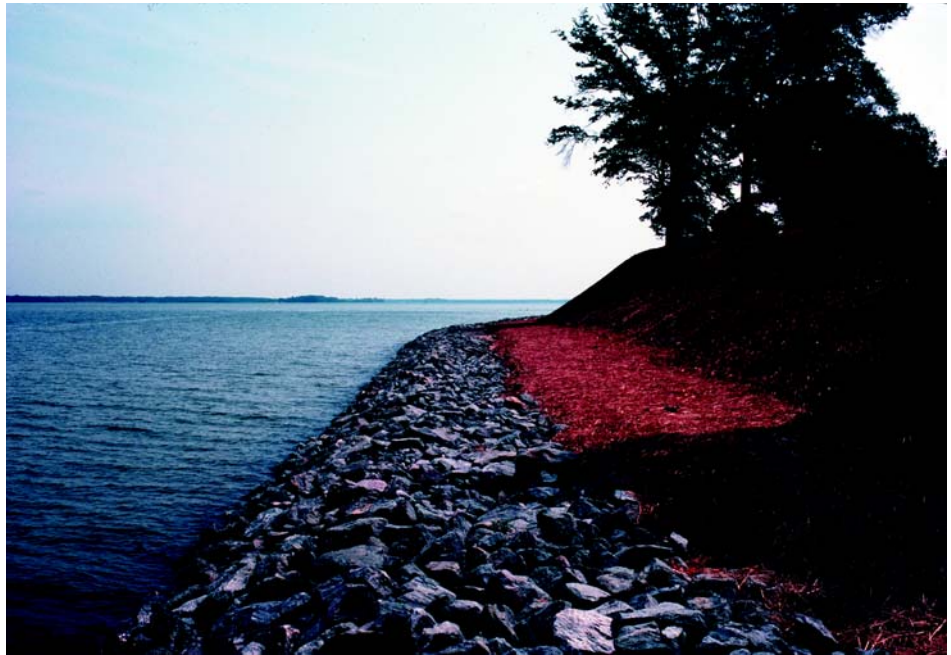
Figure 16A

Stone revetment shortly after construction on the Potomac River, Va.

Figures 16A & 16B show an example and a typical design cross-section of a stone revetment placed along a high bank. Revetments need to be high enough to withstand waves that may break over the top of the structure in extreme conditions. Banks usually need to be graded in order to obtain a stable slope. Armor stone must be good quality and proper size in order to support the size structure needed for a given shoreline. Armor made of

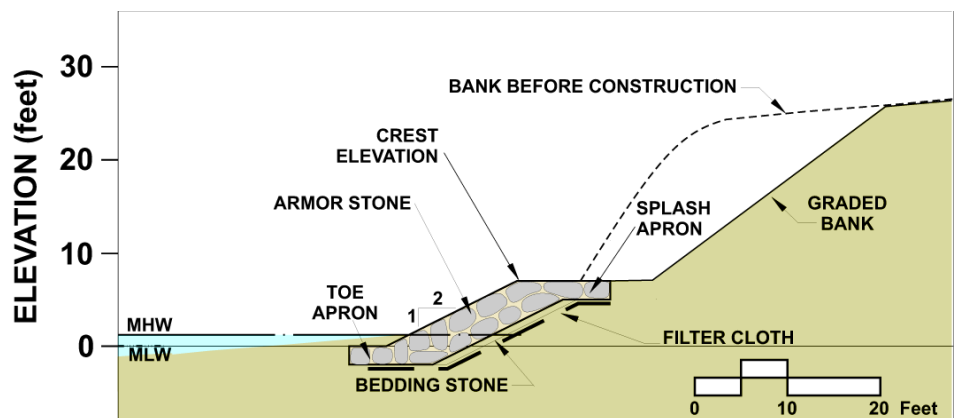
Figure 16B.

Cross-section of elements necessary for proper stone revetment design. There are usually two layers of armor stone over a bedding stone layer with filter cloth between the earth subgrade and bedding layer. Armor size is dependent on the design wave height which is determined from an analysis of wave climate for each project site.

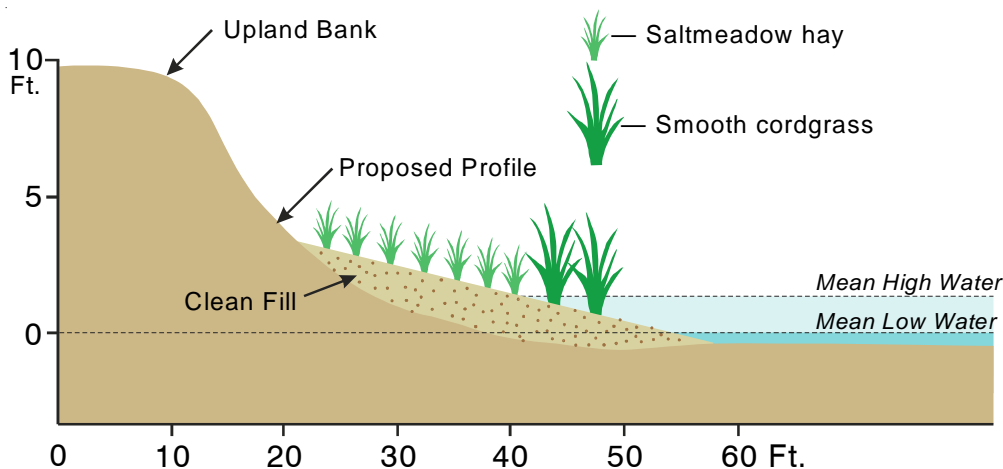
Figure 25D
This cross section shows a proposal plan to stabilize a typical eroding shoreline using clean sand to create the appropriate planting area.
